Finite Element Analysis of WaterFence- Water Load and Wind Load

The following is a brief report on the findings of wind loaded and water loaded finite element analyses performed on the WaterFence assembly. The model file used for both tests was 19681-02 B_R B6. The resin properties used were based on the Surpass RMs-539-U. The wall thickness of the fence/tank for all tests was .3125". Below in Fig. 2, is a plot of the mesh applied to the tank/fence part and post. Yield Strength = 2900 psi, Poisson's Ratio = 0.394. The analyses were both non-linear.

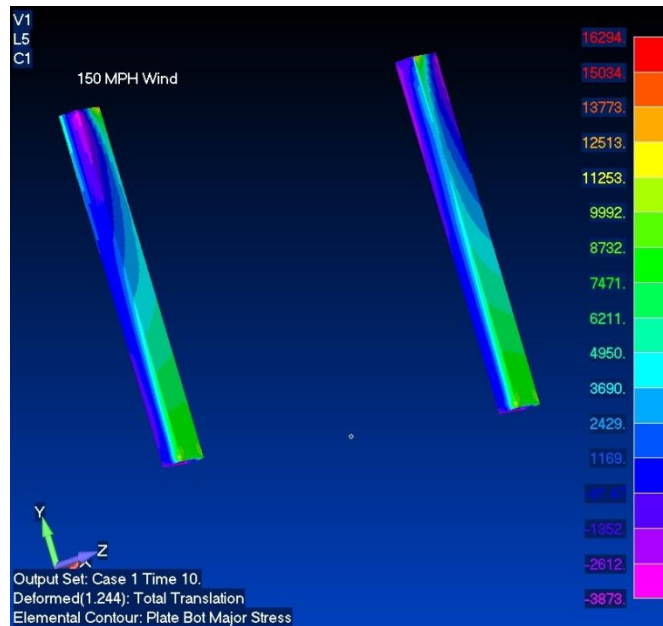
In fig. 5, the stresses are shown for the HSS fence posts. The wall thickness of the hollow rectangular tubes was .125". The posts were constrained from movement in all directions at the bottom.

Fig. 5: Fence Post Stresses at 150 mph.
